Monthly Oversight Report 42  
ACS NPL Site  
Griffith, Indiana  
May 29, 2004 - June 25, 2004

Subject: Monthly Oversight Summary Report  
No. 42 for June 2004

**Monthly Oversight Summary Report No. 42**  
**ACS Superfund Site WA57, 46526.238**

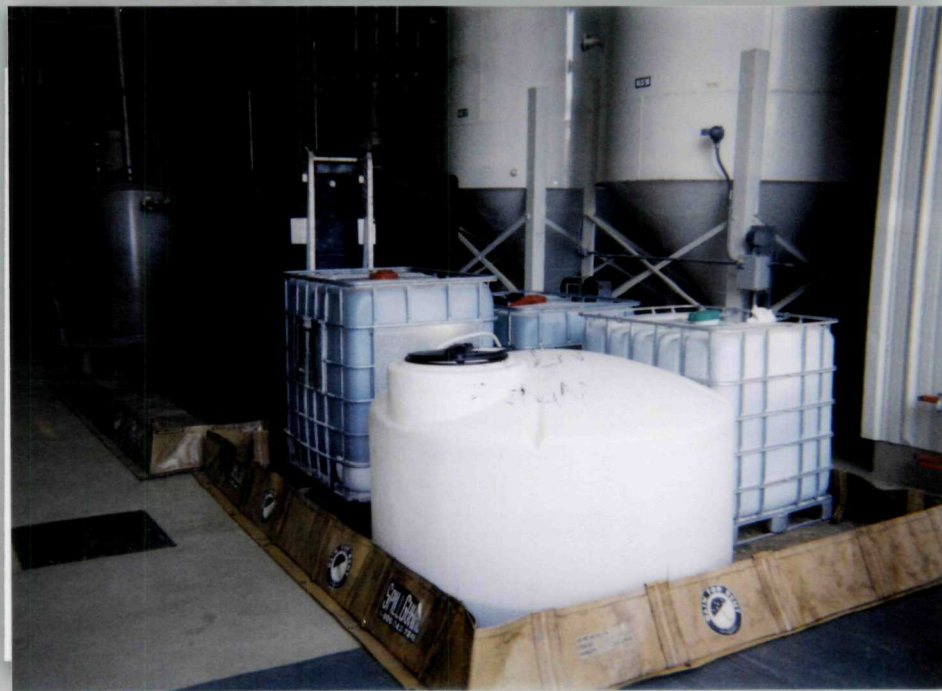
Description: Photo facing southwest showing a new group of temporary acid storage tanks. Note the secondary containment that has been added recently.

During the week of June 14, 2004, MWH rented several poly tanks to temporarily store the sulfuric acid. BVSPC expressed concern that the rental tanks did not have secondary containment. MWH subsequently installed secondary containment for the tanks during the week of June 21, 2004. MWH reported that it transferred approximately 4,000 gallons of diluted sulfuric acid from the leaking tank and its secondary containment into the temporary poly tanks. MWH also reported that it identified two leaks in the storage tank, one at the inlet valve and the second at the outlet valve, both located near the base of the tank. MWH is currently evaluating whether it will replace or repair the leak. MWH also reported that it is evaluating locations where it can either dispose of or recycle the diluted sulfuric acid.

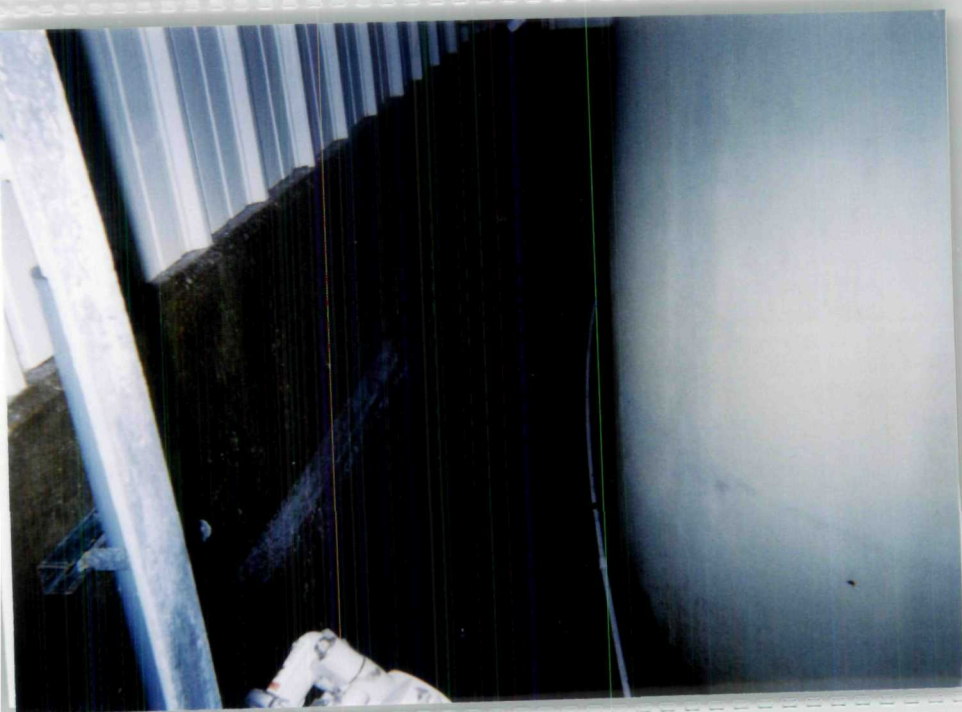
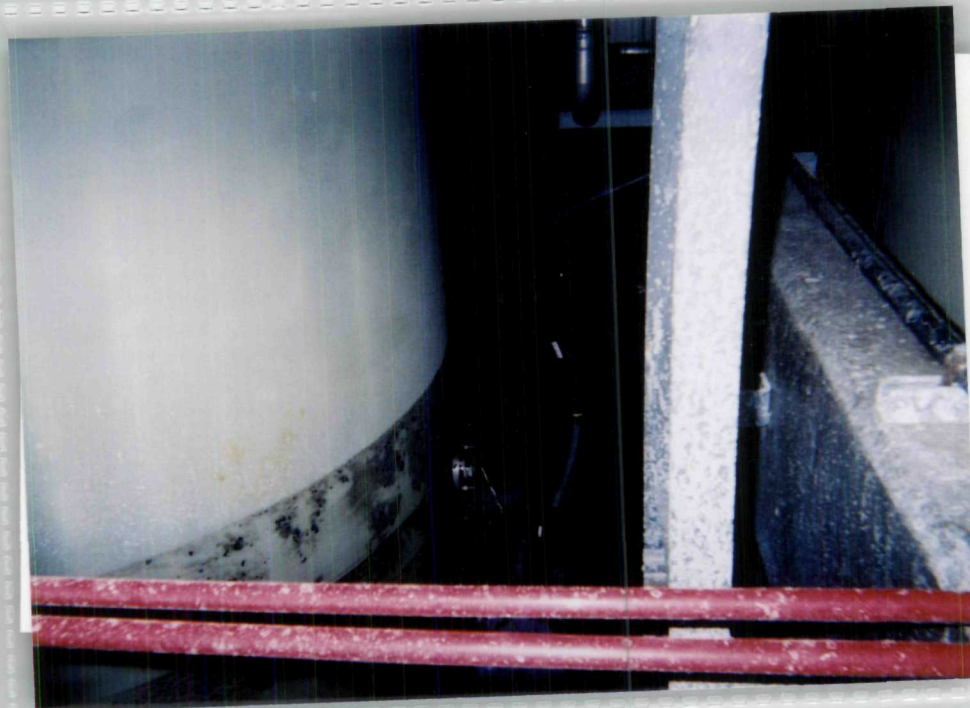
Description: Photo facing west on the north side of the sulfuric acid tank after diluted acid was pumped from the secondary containment. Note approximately 2 feet deep.
